Kentucky Avenue Bridge over Rock Creek KCMO Bridge No. S022B21 Bridge Rehabilitation Study

July 14, 2020

Kentucky Avenue Bridge over Rock Creek (Br. No. S022B21)
Bridge Rehabilitation Study

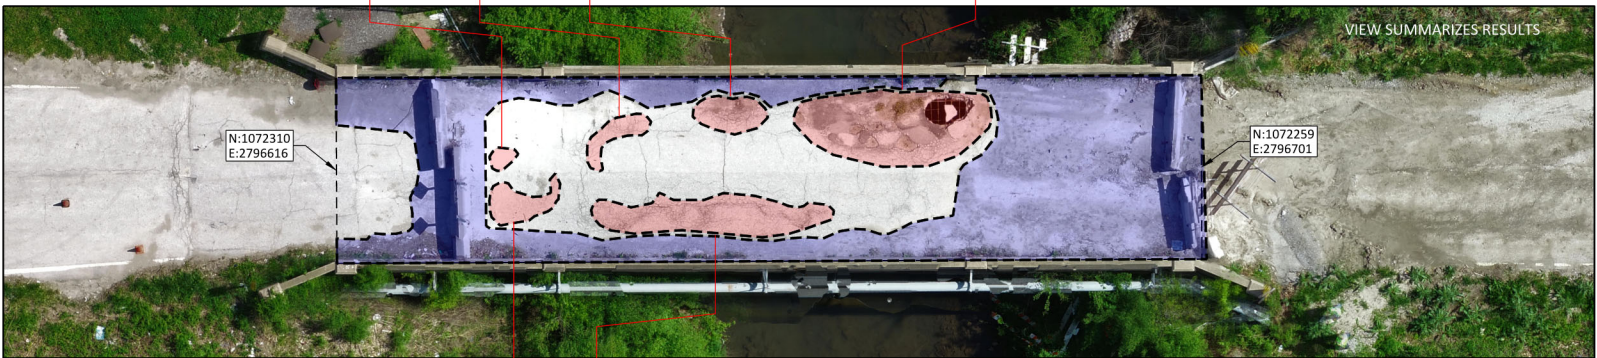
STEP 4: RESULTS
Scale: 1" = 10' (Full Size)

DECK SURFACE = ~ 2,000 SF
AREA OF DECK UNABLE TO SCAN = ~ 1,075 SF
AREA OF DECK SCANNED = ~ 925 SF
DAMAGE AREA = ~ 330 SF
% DAMAGE = ~ 36%

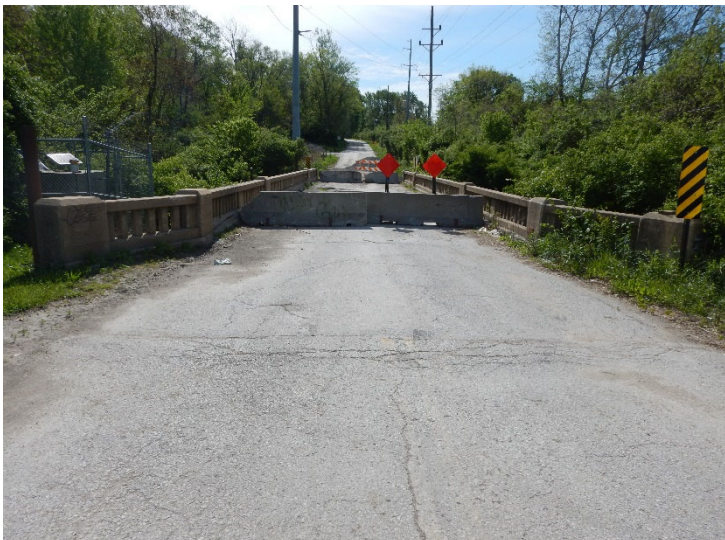
PHOTO 1 LOOKING EAST: Temporary concrete barriers at west end of bridge

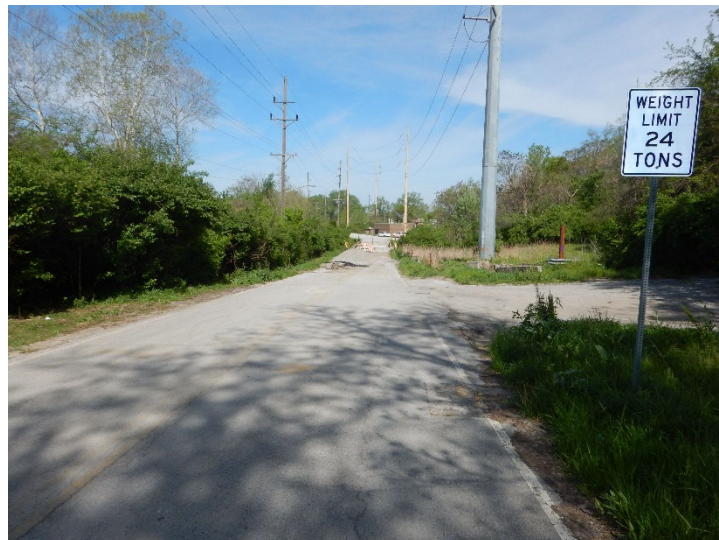
PHOTO 2 LOOKING WEST: Roadway looking west; 24 Ton sign on east approach; overhead power lines on both sides of roadway

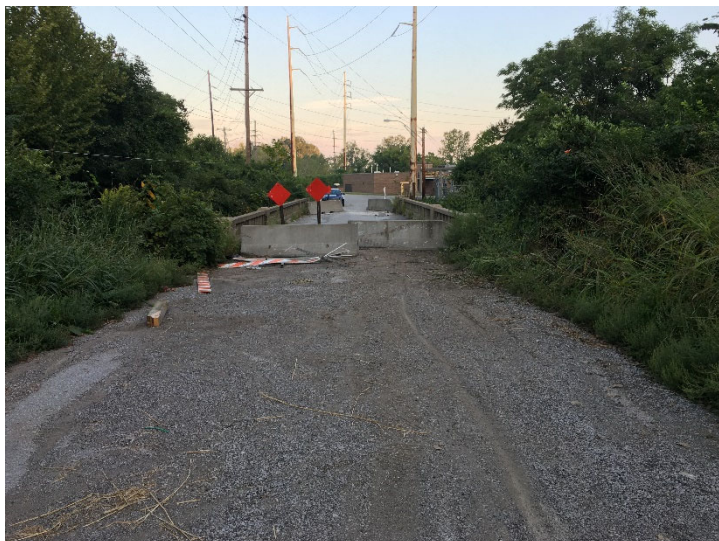
PHOTO 4 LOOKING WEST: Temporary concrete barriers at east end of bridge

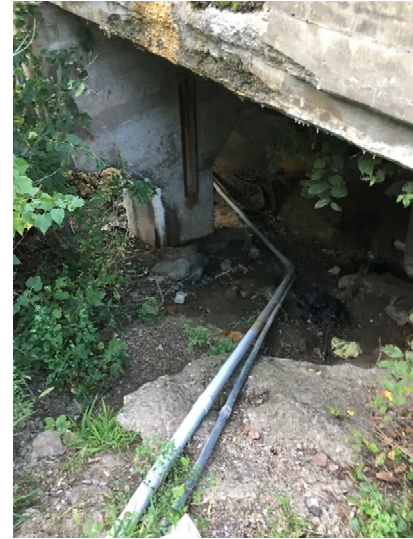
PHOTO 6 LOOKING SOUTHEAST: Stream gauging station intake pipes laying on ground under west span of bridge

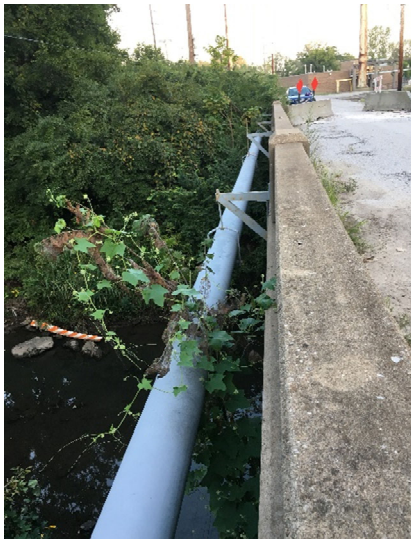
PHOTO 7 LOOKING WEST: 12 in. diameter gas line attached to south side of bridge

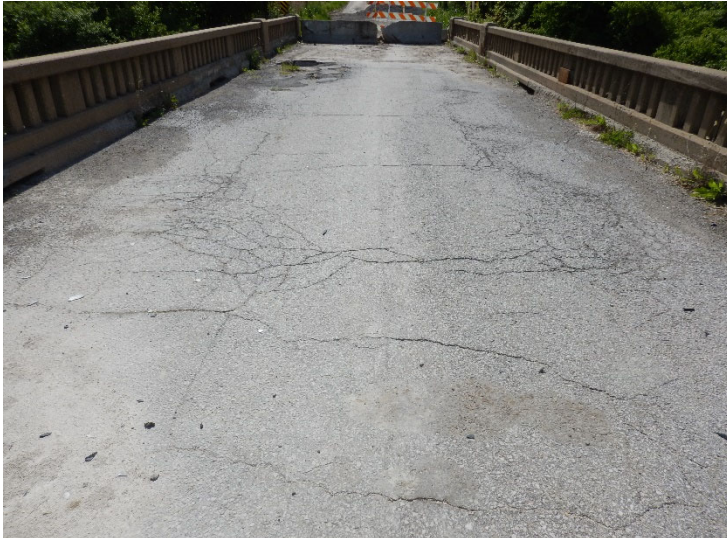
PHOTO 9 LOOKING EAST: Concrete bridge deck with asphalt overlay

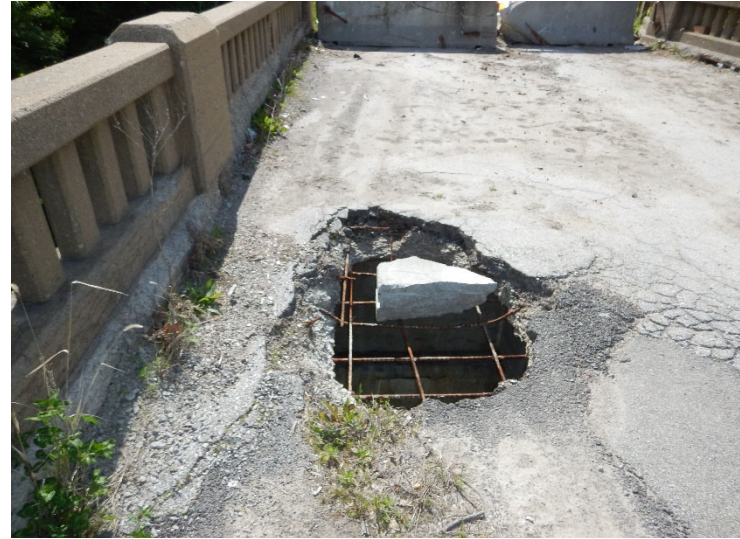
In the 2018 biennial bridge inspection report for this bridge, the overall condition is described as being Fair. Subsequent to that inspection a hole developed in the bridge deck at the east end of the main span, and the bridge was closed to vehicular traffic. The condition of the top surface of the concrete deck cannot be determined by conventional methods because of the asphalt overlay. The overlay is in poor condition. The bridge barriers are in fair condition with cracking and deterioration, and exposed reinforcing steel along the curb lines. The bottom of the deck has cracking with efflorescence in all spans. The tee girders in the main span, the piers and abutments all have areas with spalling and exposed reinforcing steel. In general, the slab spans, main girders, and substructure members are in fair condition and do not warrant immediate replacement. In the current condition, the bridge likely would be eligible for federal replacement funds.

PHOTO 10 LOOKING EAST AT EAST END OF MAIN SPAN: 5.5 ft. x 3.5 ft. hole in bridge deck

This alternative is to do the minimal repairs required so that the bridge can safely carry traffic for an additional 5-10 years without significant additional investment. The approach to this repair will be to mill off the asphalt overlay, patch concrete deck areas with active spalling - either full or partial depth - and place a new asphalt overlay on the deck. The existing bridge rail and approach guardrails will not be addressed as part of this alternative. The current load posting for the bridge is 24 tons. No plans are available for the existing bridge so it cannot be accurately load rated. Since no signs of structural distress are noted, it would be acceptable to leave the current posting. However, since the nature of this alternative is not to repair everything that is wrong with the bridge, the City might consider lowering the post to 15 or 20 tons. This would allow most type of residential traffic to cross the bridge, but could discourage heavy truck loads from nearby commercial sites.

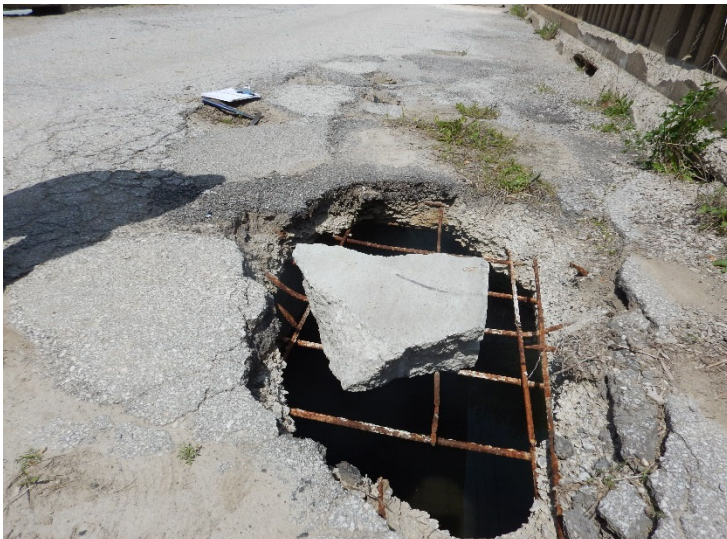
PHOTO 11 LOOKING WEST AT MAIN SPAN: 5.5 ft. x 3.5 ft. hole in bridge deck

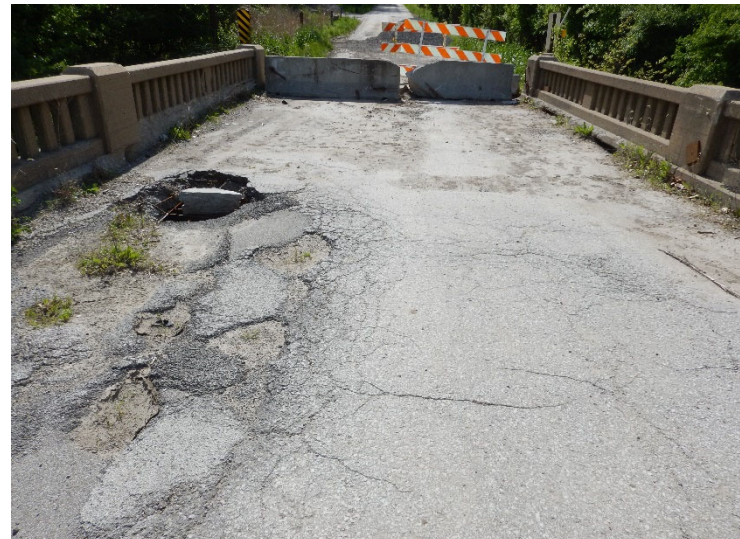
PHOTO 12 LOOKING EAST AT MAIN SPAN: Potholes in asphalt overlay in WB lane

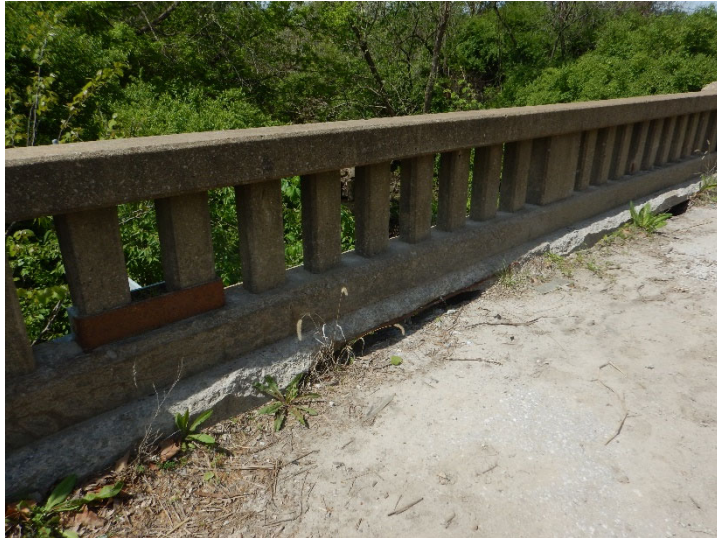
PHOTO 13 LOOKING SOUTH: Spalling on curb at south bridge rail

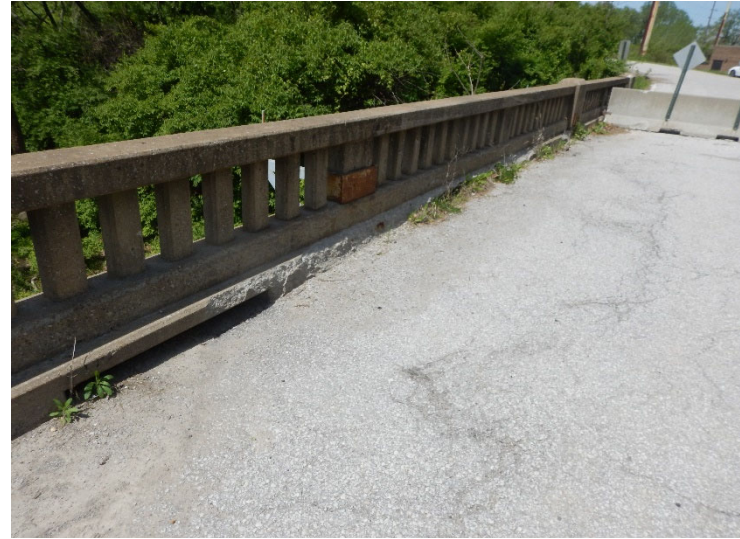
PHOTO 14 LOOKING SOUTH: Spalling on curb at south bridge rail

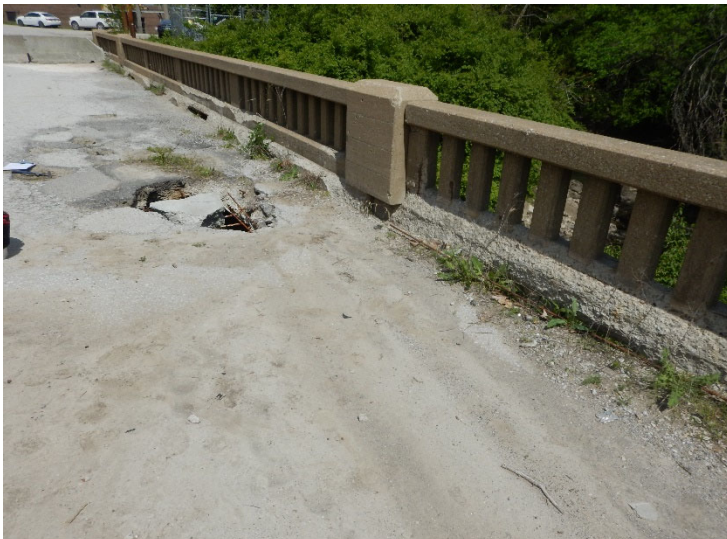
PHOTO 15 LOOKING NORTH: Spalling on curb at north bridge rail

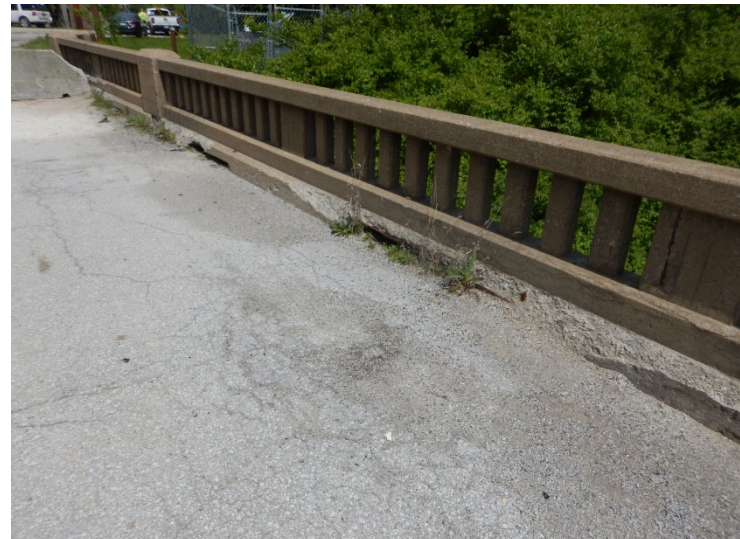
PHOTO 16 LOOKING NORTH: Spalling on curb at north bridge rail

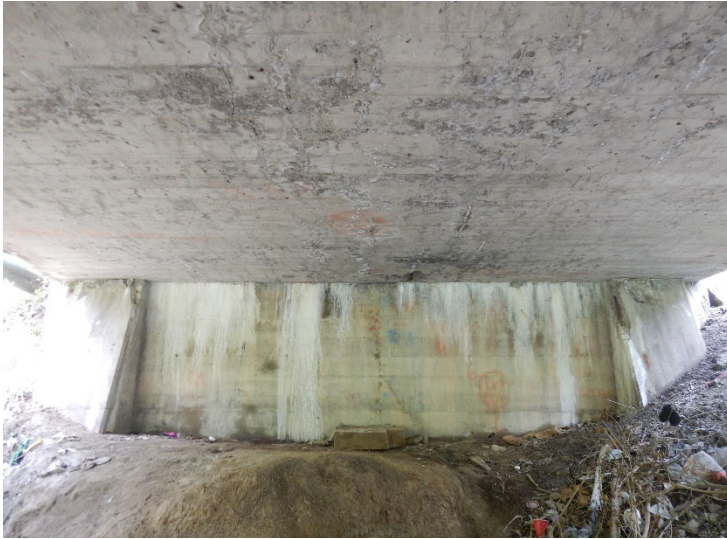
PHOTO 17 LOOKING WEST: Moderate efflorescence on west abutment

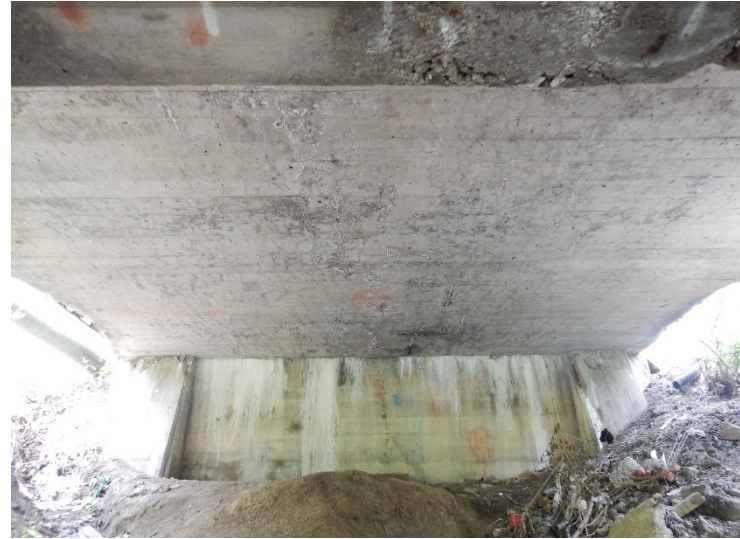
PHOTO 18 LOOKING WEST: Cracking and areas of moisture on bottom of reinforced concrete slab span

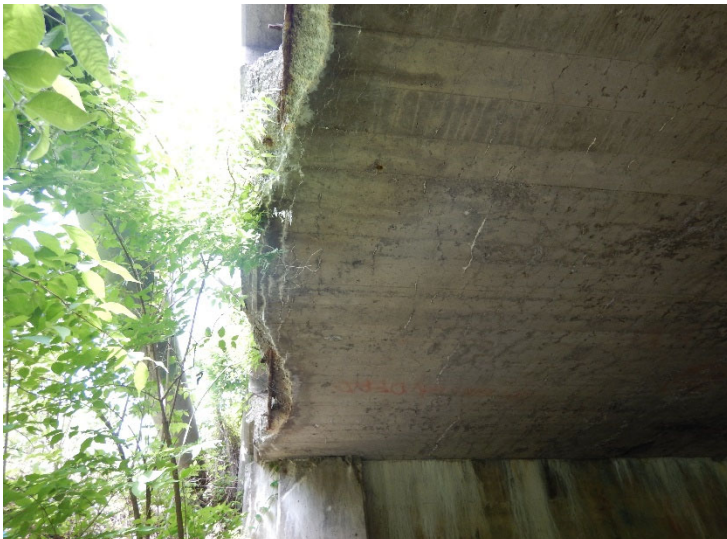
PHOTO 19 LOOKING WEST: Heavy spalling with exposed reinforcing steel on south edge of slab

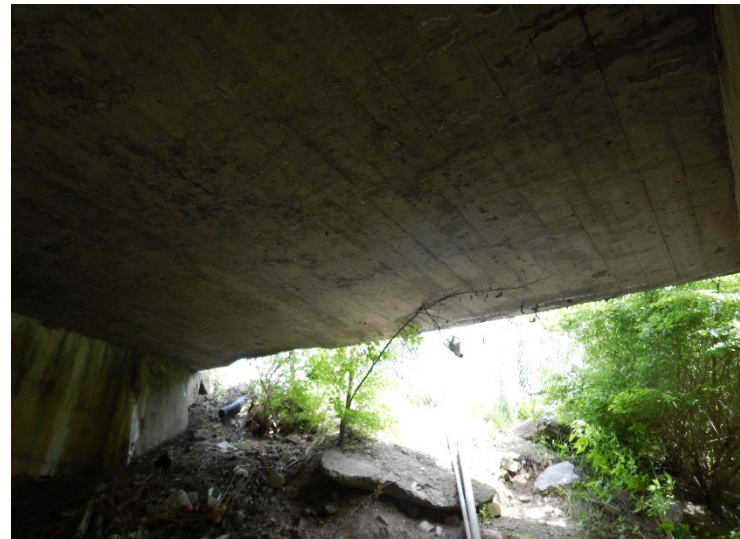
PHOTO 20 LOOKING NORTH: Moderate spalling with efflorescence on north edge of slab

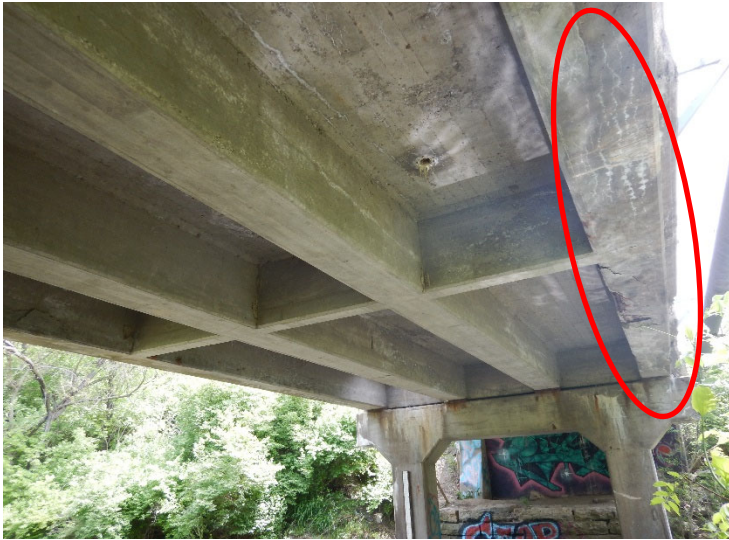
PHOTO 21 LOOKING EAST: Cracking, efflorescence and some spalling with exposed reinforcing steel on south girder

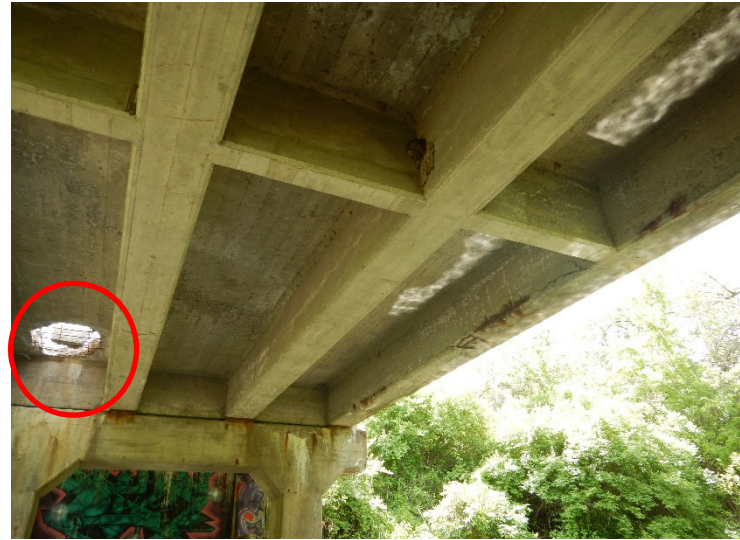
PHOTO 22 LOOKING EAST: Two interior girders in satisfactory condition; **hole in deck near east pier**

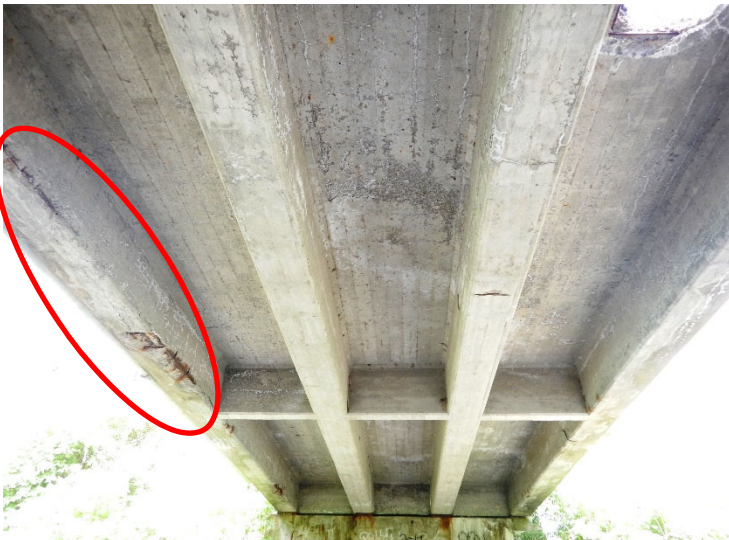
PHOTO 23 LOOKING WEST: **Cracking, efflorescence and some spalling with exposed reinforcing steel on south girder**; bottom of concrete deck in fair condition overall

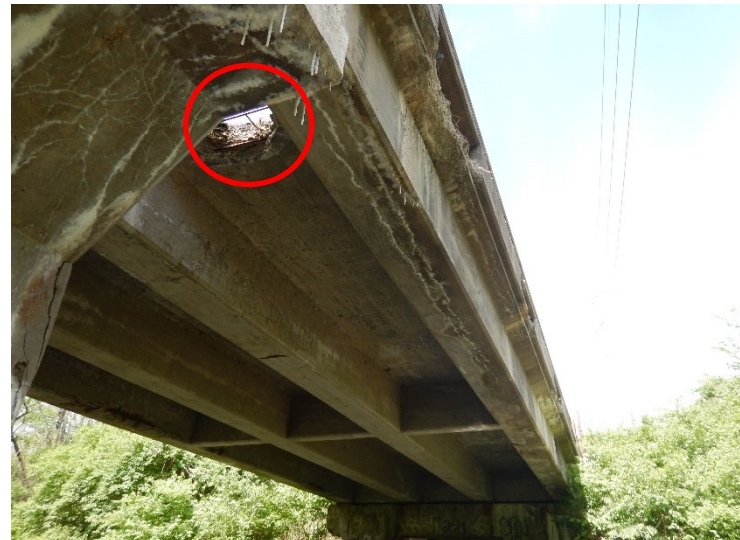
PHOTO 24 LOOKING WEST: Cracking and efflorescence on north girder; **hole in deck near east pier**

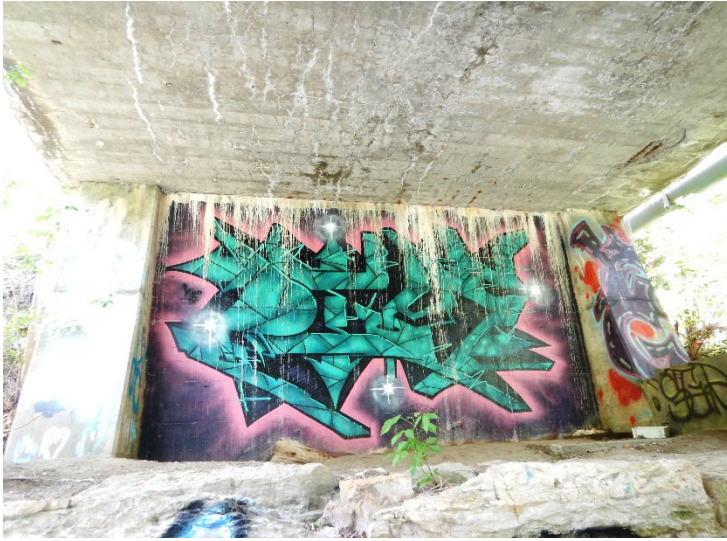
PHOTO 25 LOOKING EAST: Moderate efflorescence on east abutment

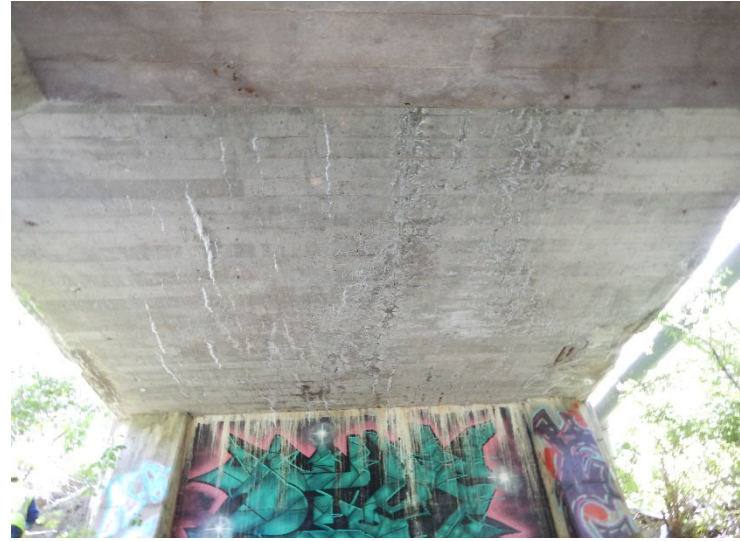
PHOTO 26 LOOKING EAST: Cracks with efflorescence and moisture staining on bottom of reinforced concrete slab span

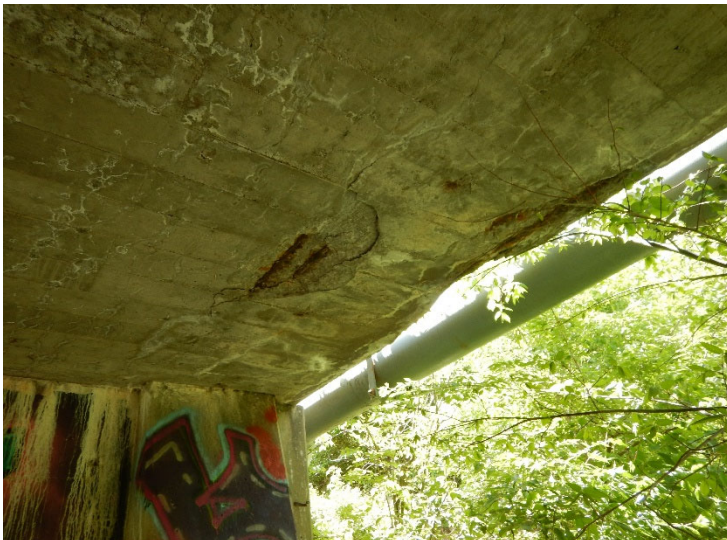
PHOTO 27 LOOKING SOUTHEAST: Spalling with exposed reinforcing steel along south edge of slab

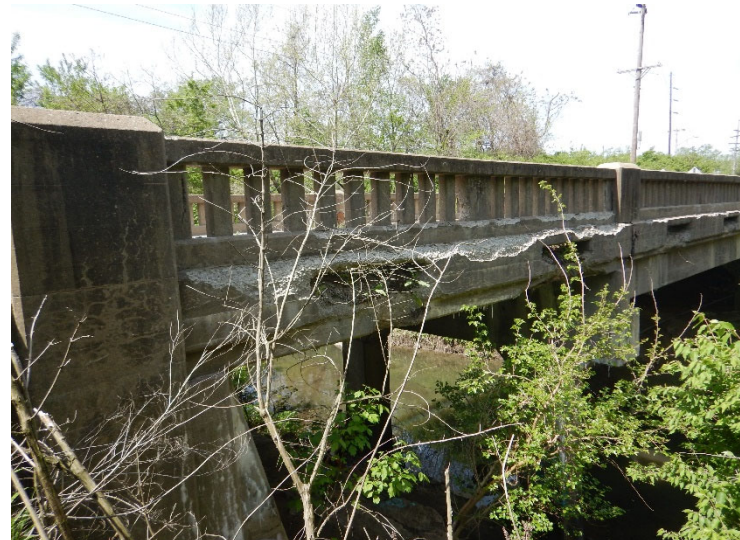
PHOTO 28 LOOKING SOUTHWEST: Spalling on exterior side of north barrier

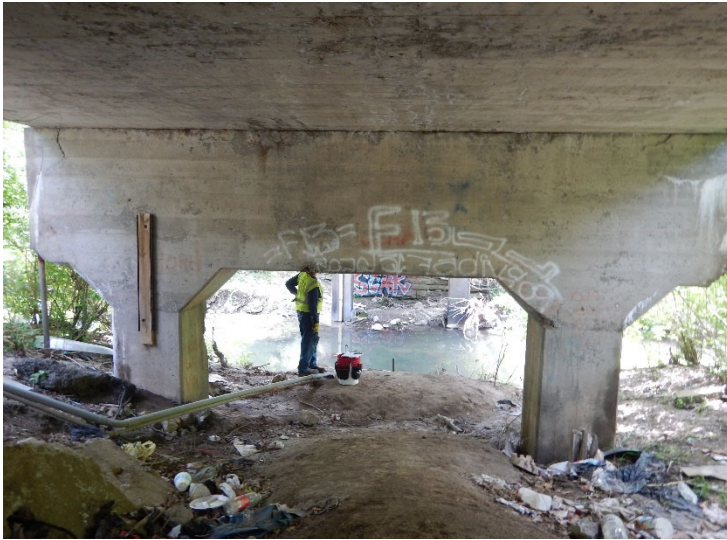
PHOTO 29 LOOKING EAST: West pier west face has minor cracking and efflorescence at both ends of cap

The substructure of this bridge, particularly the piers, have many places with deterioration and spalling that are not structural in nature. For the short term repairs, we recommend just knocking off the loose concrete and coating the exposed surfaces with an epoxy material to inhibit the continued deterioration of the concrete and reinforcing steel.

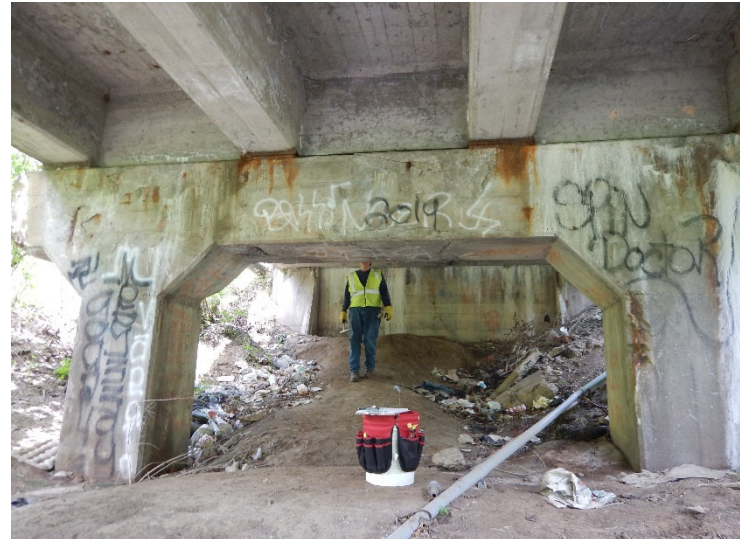
PHOTO 30 LOOKING WEST: West pier east face has cracking, rust staining, delamination and efflorescence on cap

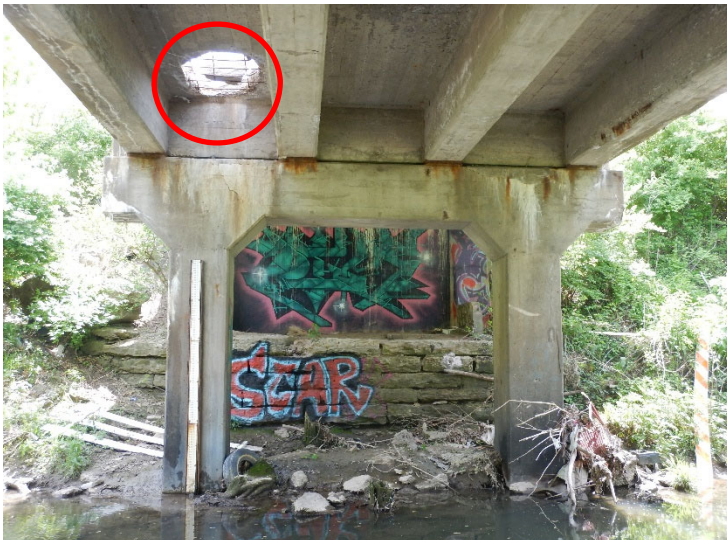
PHOTO 31 LOOKING EAST: East pier has cracking, rust staining and efflorescence on cap; rock retaining wall under east approach span; **hole in deck near east pier**
